# **THE OTTER CONSULTANCY**

### **ECO-POWER PROJECT BLACKBRIDGE, MILFORD HAVEN.**

## **PROPOSED NEW ROAD INTO SITE: OTTER SURVEYS & MITIGATION REPORT**

**JUNE 2017**

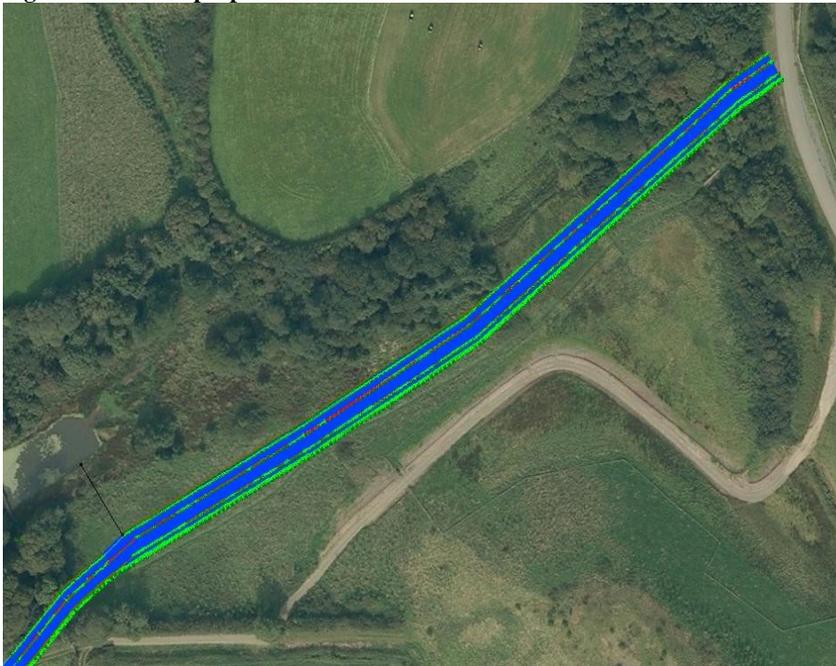
**Fig 1** Location of proposed new road.

A new road access into the site is proposed at a point upstream from the reservoirs, to connect with the existing West Perimeter Road (Fig 1).

The new road will lie adjacent to the inflow stream that flows into the reservoirs and continues down to the Daugleddau. An otter survey was undertaken to assess potential impacts on otters, and to identify mitigation measures.

1. A solid 1.8m high wooden fence should be erected along the length of the new road (from the LNG road to the reservoir) adjacent to the stream & reservoir (as shown in Fig 1).

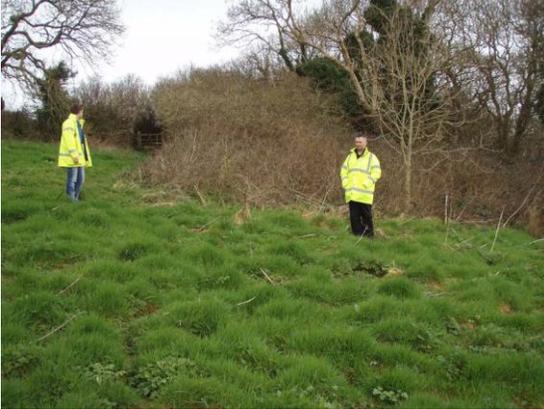
**Plate 1 Dense bramble down to reservoir 2.**

Site	Description
1.	Block of dense bramble that extends from the shore of reservoir 2 up to the foot path (Plate 1). <b>Potential Resting Site</b> , but scrub may be disturbed by dogs if allowed to run free from the FP.

5. An artificial holt should be installed in the bramble scrub (Site 1) and the blackthorn / bramble scrub (Site 4 / 5). In addition, 1/3<sup>rd</sup> of the blackthorn thicket should be coppiced during the winter with cut brush piled on the installed artificial holt.

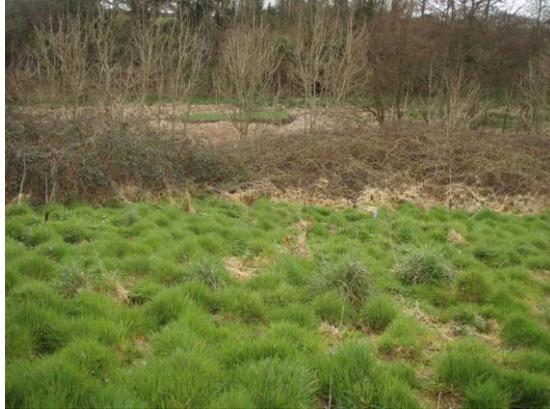
**Plate 2 Rough grassland with bramble fringe**

2.	Rough grassland on slope down to narrow bramble fringe along bank top (Plate 2).
3.	Bank edge dominated by small area of willows with little ground cover (Plate 3).

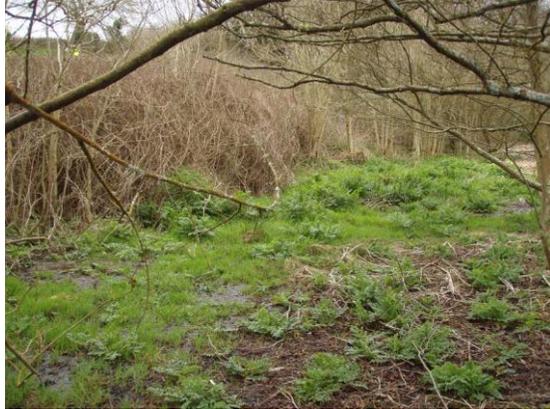
**Plate 4 Long bramble thicket.**

4.	Long thicket of blackthorn / bramble with little cover at ground level (Plate 4). Scrub may be disturbed if dogs allowed to run free from the FP.
5.	Dense bramble thicket with alders along bank edge (Plate 5). Signs of mammal paths through edge of bramble (badger prints found in mud nearby).

3. The long stretch of scrub (Site 4) is too tall and 'leggy' to provide suitable resting cover for otters, but could be improved by coppicing & installation of an artificial holt.

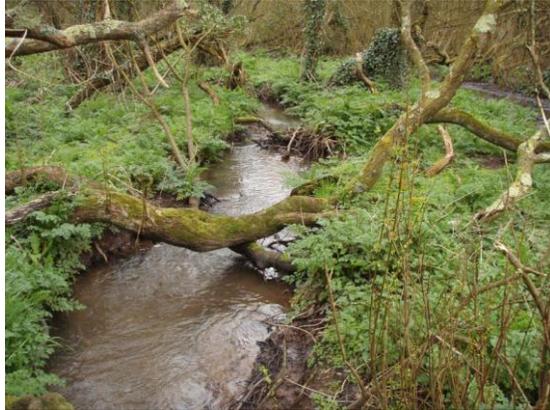
**Plate 6 Stream with little otter cover.**

6.	Stream is 1 – 2m wide with good flow. Bank height approx 300 mm (Plate 6). No cover for otter resting sites.
7.	Extensive gorse thicket with willows & alder (Plate 7). The gorse / willow scrub along stream is leggy and open at ground level.

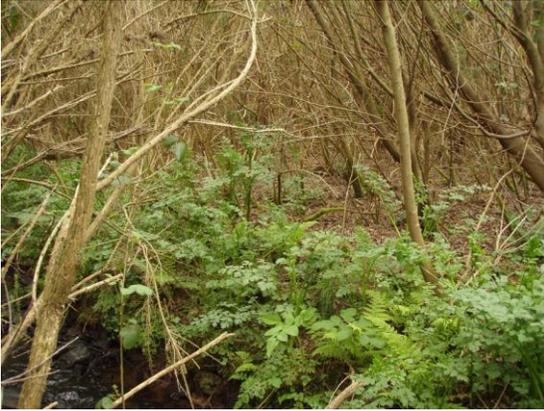
**Plate 7 Leggy gorse thicket.**

4. The proposed road is close to the stream at Site 7. The habitat at this location is tall (approx 2m high), leggy gorse with no ground cover so that the vegetation cover will not provide a screen between road and stream.

2. At an early stage in the scheme the 'leggy' gorse at Site 7 should be coppiced to encourage dense re-growth, with cut gorse etc used as a 'dead hedge' between what will be the edge of the new road and the scrub.

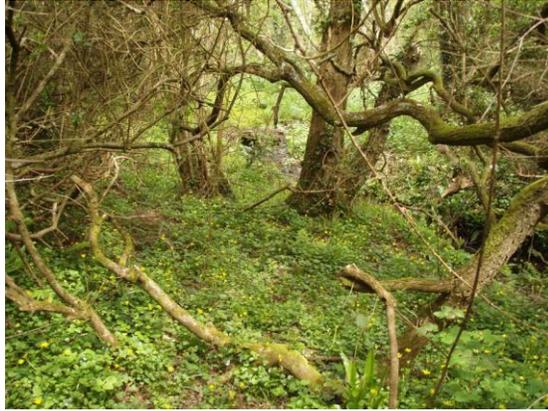
**Plate 8 Woodland along stream, little otter cover.**

8.	Stream-sides with woodland, fallen trees & bramble scrub but with little ground cover (Plate 8).
9.	Stream & small tributary confluence in leggy wet woodland with fallen trees (Plate 9). Little suitable dense ground cover for otters.

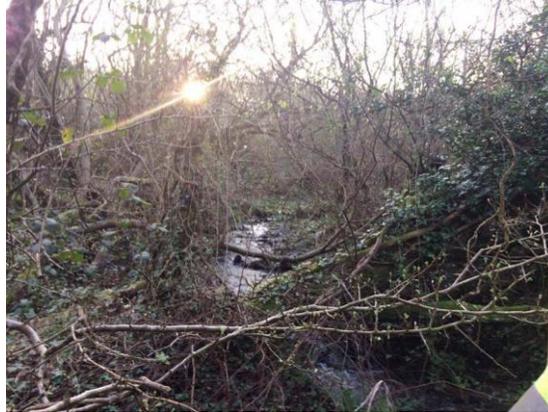
**Plate 10 Small tributary to be culverted.**

10.	Small tributary to be culverted for the new road flows through wet woodland with fallen trees and sparse ground cover (Plate 10). No resting sites found.

3. The culvert over the small stream should be oversized to provide an otter ledge on one side of the culvert, and to ensure that there is always at least 400mm headroom between top of culvert & high water flows. Otter guide fencing should be installed to ensure that otters cannot gain access to the road.
